# EVALUATION OF CONCRETE CORES FROM WATERBURY DAM, WATERBURY, VT.

Carl E. Pace, Richard L. Stowe, G. Sam Wong

September 1982

Final Report

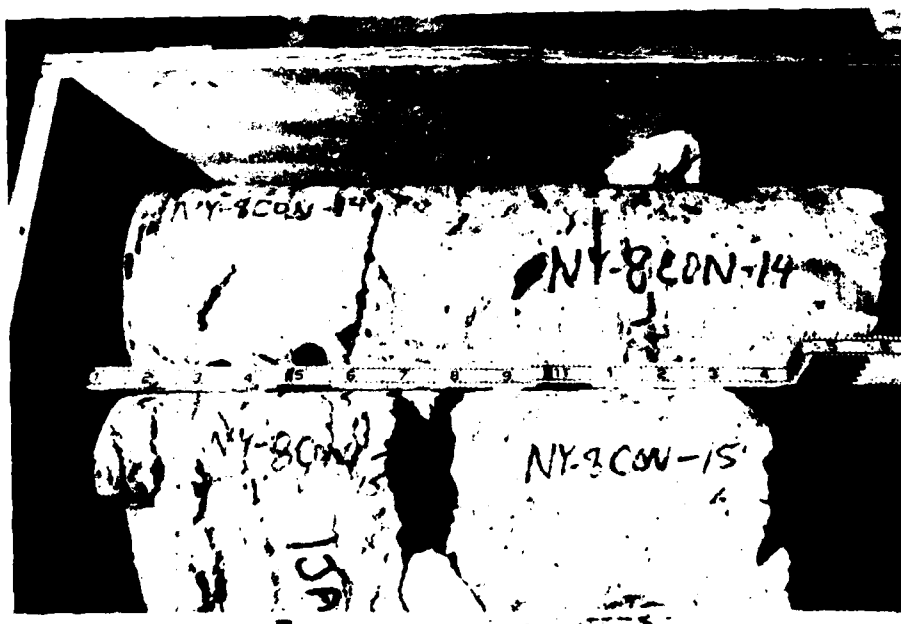
12, 3, 16, 18, 19, 21, and 23 to fractured and fragmented concrete illustrated by cores NY-8 CON-2, 5, 11, 14, and 15 (Figure 2). Other cores showed areas of poor consolidation and loose contact of new concrete with old concrete. The core logs (Figures 3-28) describe the nature of the cores received for examination. Maximum depth of deterioration was 1.4 ft as shown by core NY-8 CON-5.

Figure 2. Samples NY-8 CON-14 and 15 showing near-surface incipient cracks

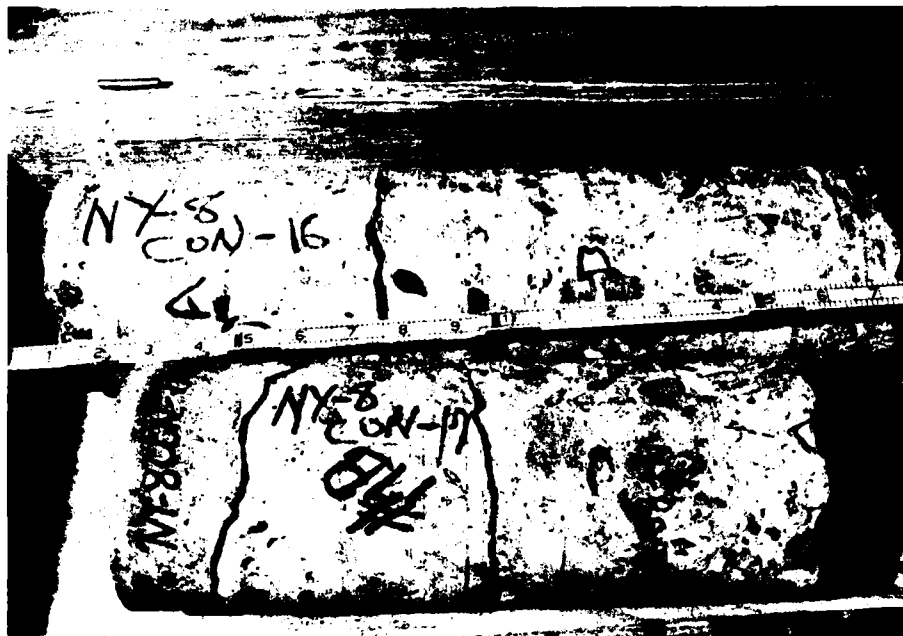
14. Much of the mortar overlay material separated along the mortar to concrete interface; this was the case in cores NY-8 CON-3, 4, 8, and 17, as indicated in Figure 29. In core NY-8 CON-10, the mortar and about 0.10 ft of concrete separated from the remainder of the core. The mortar and concrete of core NY-8 CON-18 remained intact and with good bond, as shown in Figure 30.

Figure 29. The mortar cap separated along the contact zone of sample NY-8 CON-17. This was common in many of the cores with a mortar cap

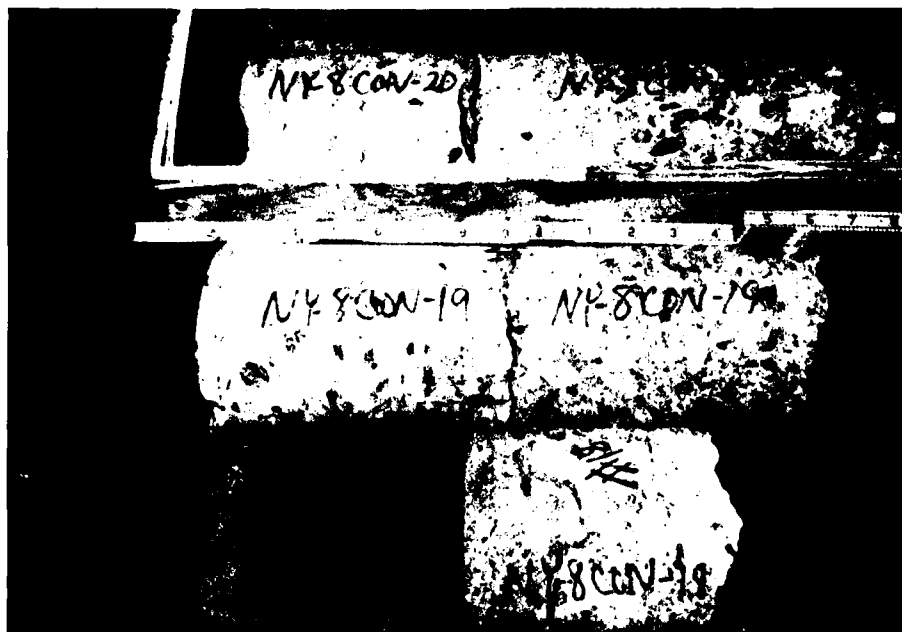
Figure 30. Sample NY-8 CON-18 shows good contact of old and new concrete. Bond at the interface continues to be strong

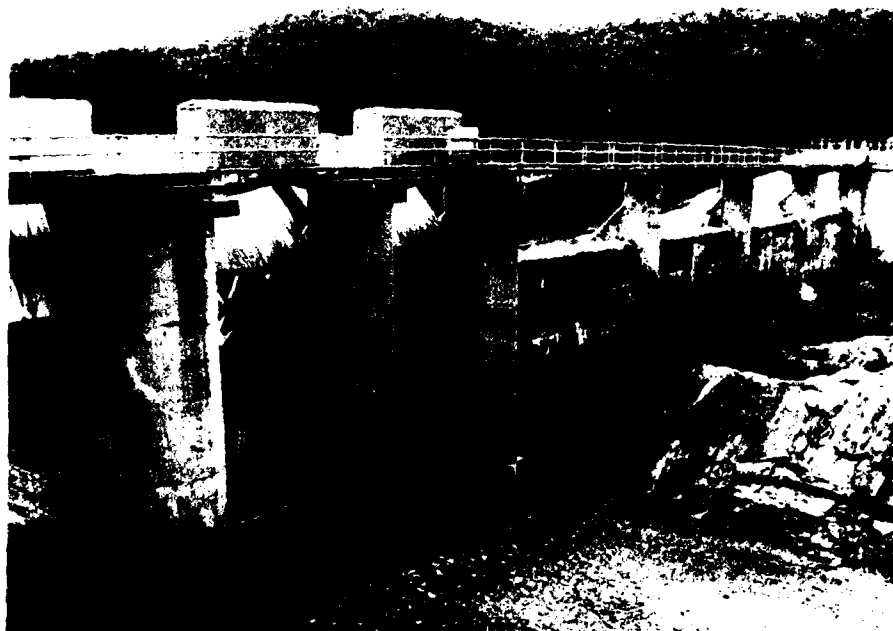
24. The upstream vertical faces of the four spillway sections have pattern cracking every 3 to 4 ft on centers. Some of the cracks are open and white exudation products are present. Views of these surfaces are presented in Figures 36 and 37.

Figure 36. From right to left, spillway sections A-4, A-3, A-2, and A-1 and a partial view of the tainter gate sections

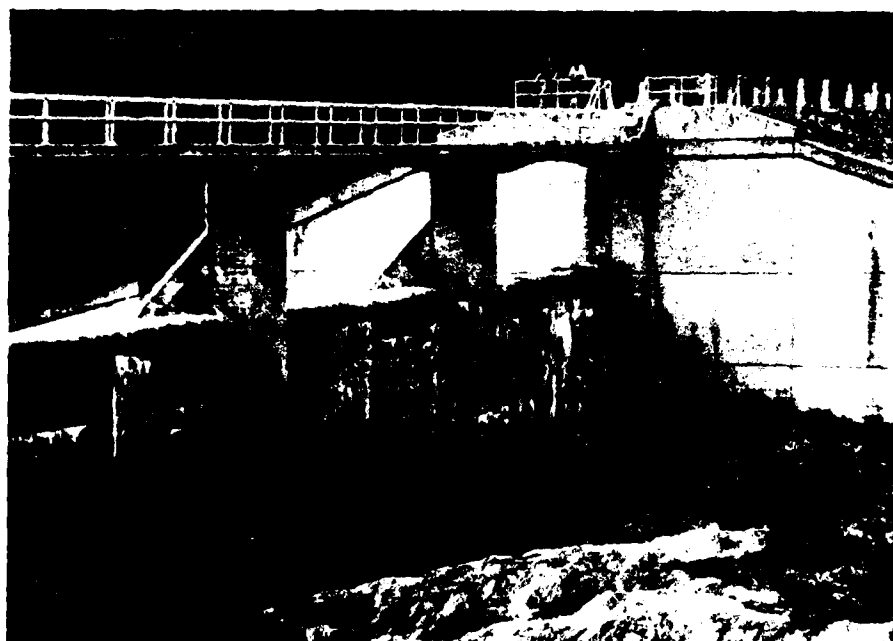
26. In general, piers No. 1 through 8 are in good condition (Figures 37 and 40). They have small local areas of deterioration due to freezing and thawing action. Pattern cracking is present, but it is nowhere so prominent as it is in the spillway section. Few cracks or exudation products are present.

Figure 37. Spillway section openings A-4, A-3, and A-2 from right to left

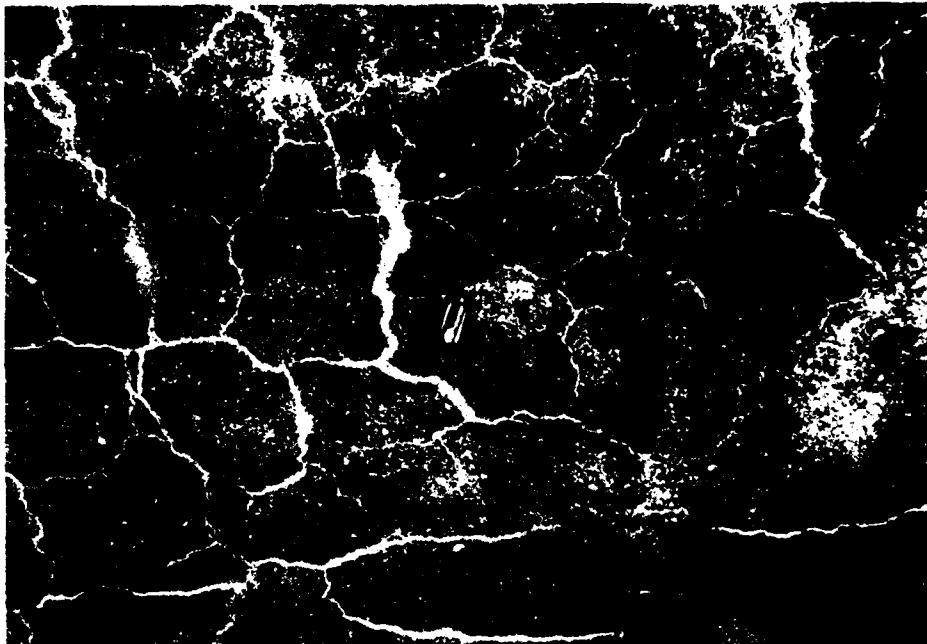
25. The bridge decking across spillway sections A-1 through A-4 is in relatively good condition. Light pattern cracking is seen on the top surface (Figure 38). There is light deterioration on the bridge decking where it comes in contact with the spillway piers No. 6, 7, and 8. The piers are numbered from east to west. A slight offset of about 1 in. on the upstream edge of one of the bridge deck sections is presented in Figure 39. The offset appears to be due to construction and not an indication of a structural deficiency.

Figure 38. Pattern cracking on the top surface of the bridge deck

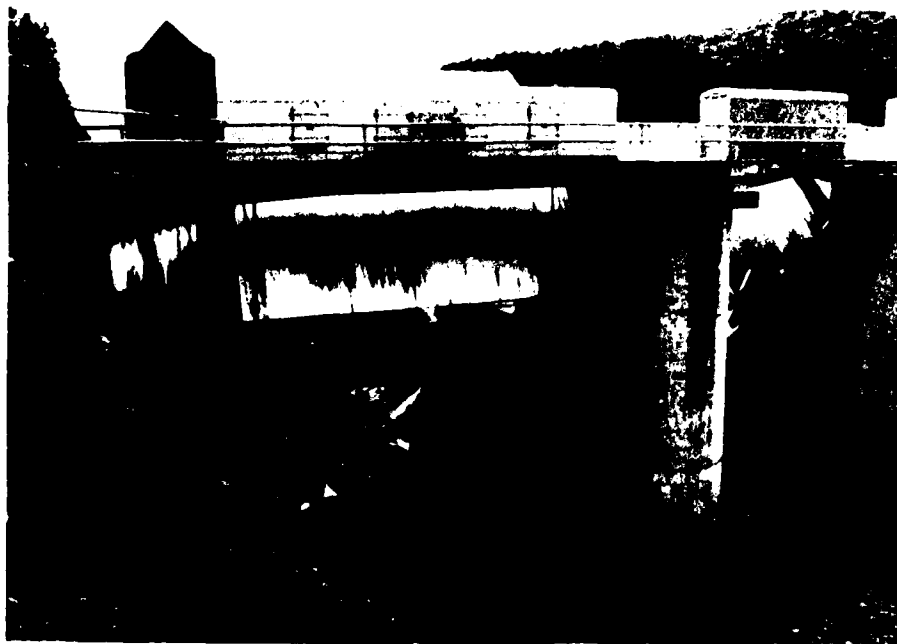
Figure 40. Typical view of tainter gate pier

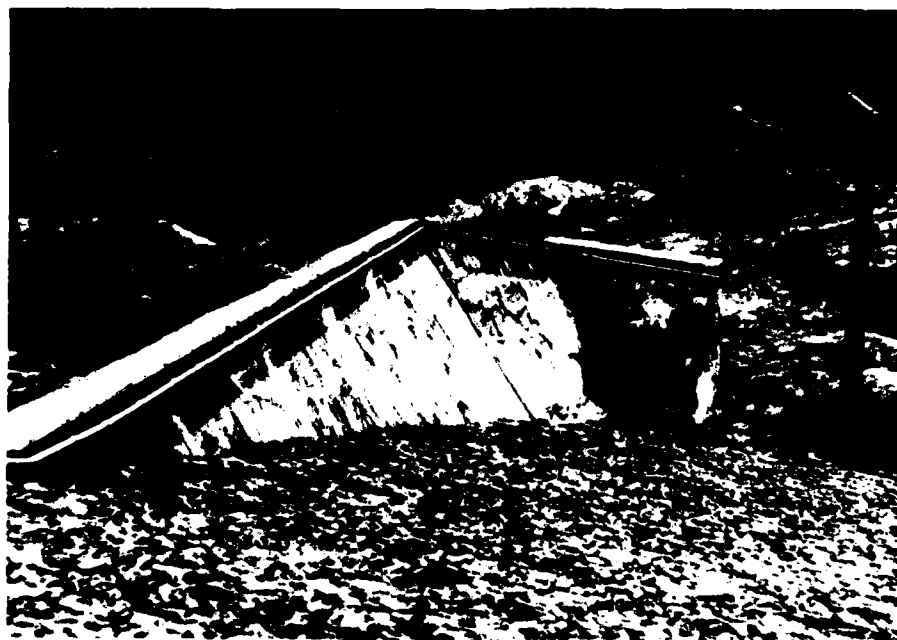
27. The concrete in the right retaining wall on the upstream side is in good condition. Several local areas of deterioration are present; white exudation is also present. Looking downstream on the right retaining wall there are a number of areas of deteriorated concrete; these areas show scaling for approximately 5 or 6 cm. Exudation is also present. The downstream retaining wall has severe surface concrete deterioration as can be seen in Figure 41.

Figure 41. Downstream concrete surface of  
right retaining wall

33. It is suggested that the dam be repaired by removing the deteriorated concrete and replacing it with a frost-resistant concrete overlay. The overlay should be doweled into the existing concrete and reinforced. Adequately frost-resistant concrete to withstand the most severe natural weathering can be produced if three criteria are met: (a) adequate air-void system, (b) sound aggregate, and (c) adequate maturity prior to being allowed to freeze and thaw in a critically saturated condition. The latter is met if concrete develops a compressive strength of 3500 psi prior to freezing. Some thin layers of overlay concrete may have a low modulus of elasticity to have more strain capacity to resist cracking. The use of organic additives ("latexes") including products such as so-called "acrylic polymers" has been advertised for this objective and may merit consideration when the overlay is less than 2 in. thick.
